Manhole Inspection Summary

Manhole # S33UU1004MH

Location Address: **6 NUT LN**

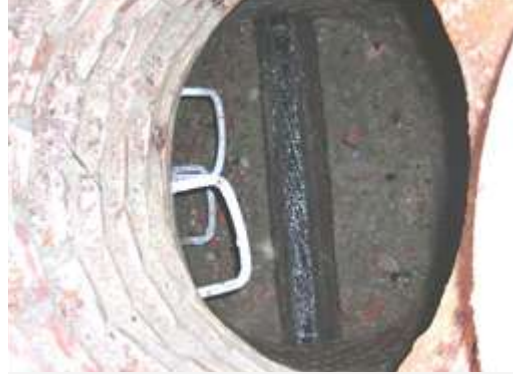
Top View

Bench debris.

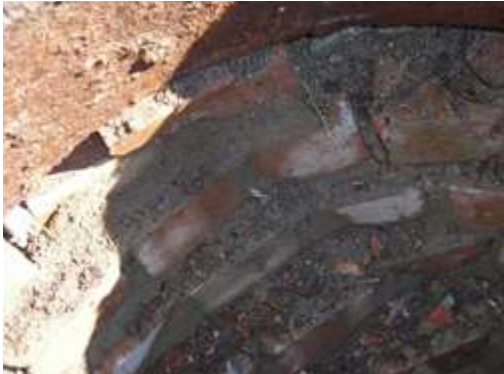
Defect

Adjustment loose brick, deterioration, and infiltration. Corbel infiltration.

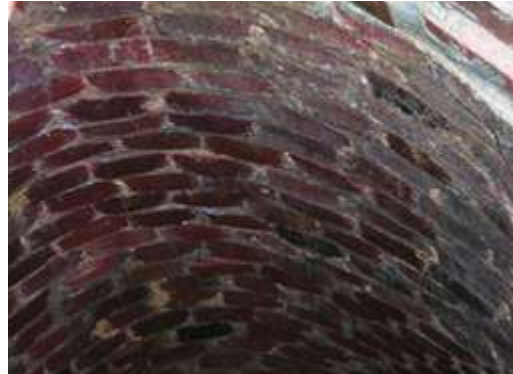
Defect

Corbel and Barrel infiltration.

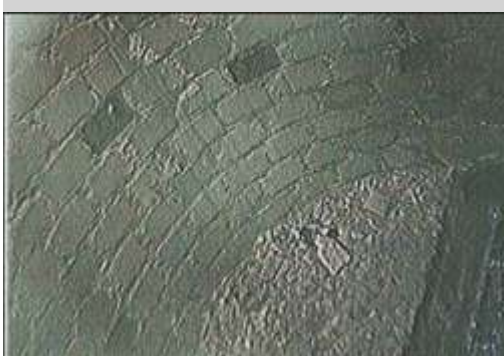
Defect

Barrel deterioration and infiltration.

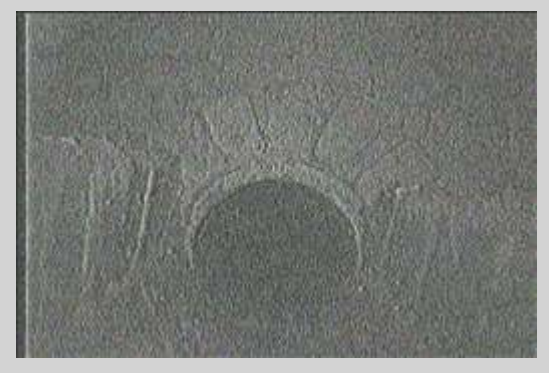
8 in. Circular Gravity Sewer Pipe Out @ 12 O'Clock

Pipe Material: **Clay** ☐ Pipe Lined

Invert Depth: **9.53** (ft.) Flow Characteristics: **Fast**

Deposits: ☒ None ☐ Mud ☐ Sludge ☐ Debris ☐ Grease

Infiltration: **None** Pipe Seal Cond: **Unknown**

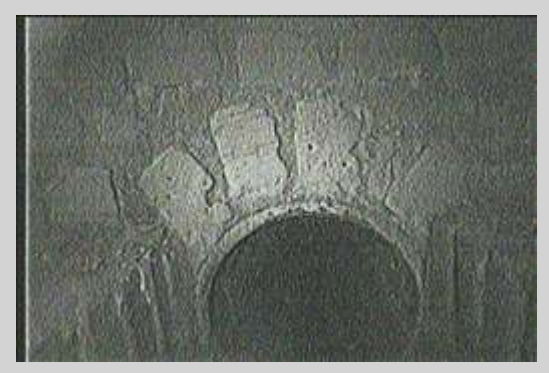
8 in. Circular Gravity Sewer Pipe In @ 6 O'Clock

Pipe Material: **Clay** ☐ Pipe Lined

Invert Depth: **9.31** (ft.) Flow Characteristics: **Fast**

Deposits: ☒ None ☐ Mud ☐ Sludge ☐ Debris ☐ Grease

Infiltration: **None** Pipe Seal Cond: **Unknown**
